# Manhole Inspection Summary

Manhole # S55S\_\_016MH

Insp Date: **3/19/09 8:28 AM**

**Location** Address: **1516 S HIGHLAND AV**

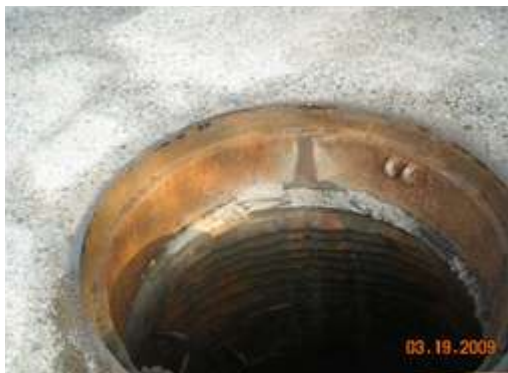
MISC.

Subject To Ponding: **Sheeting**

INFLOW EVIDENCE FROM SHEETING

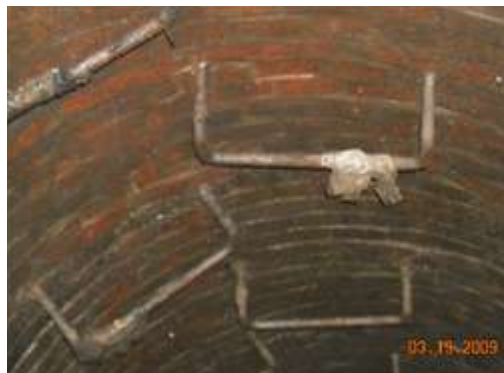
Defect 2

EVIDENCE OF SURCHARGE

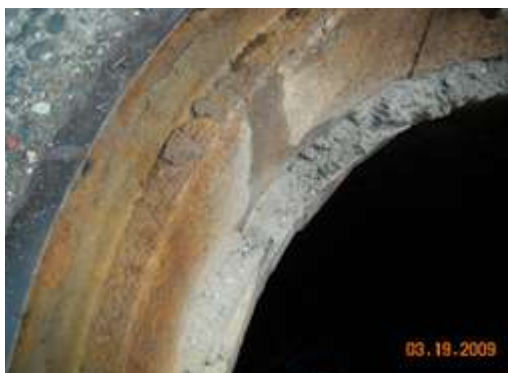
Defect 1

Offset: **1.5** (in.)

FRAME OFFSET

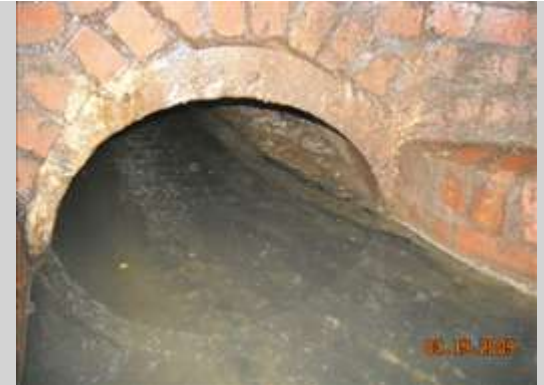
12 O'Clock Outflow

24 in. Circular Gravity Sewer  
Pipe Out @ 12 O'Clock

Pipe Height: **24** (in.) Rod and Bar (Angled)  
Pipe Material: **Clay** ☐ Pipe Lined  
Invert Depth: **19.80** (ft.) Flow Characteristics: **Slow**  
Deposits: ☐ None ☒ **Mud** ☒ **Sludge** ☐ Debris ☐ Grease  
Silt Depth: **8** (in.) Deposits Extent: **Medium**  
Infiltration: **Evidence** Pipe Seal Cond: **Sound**

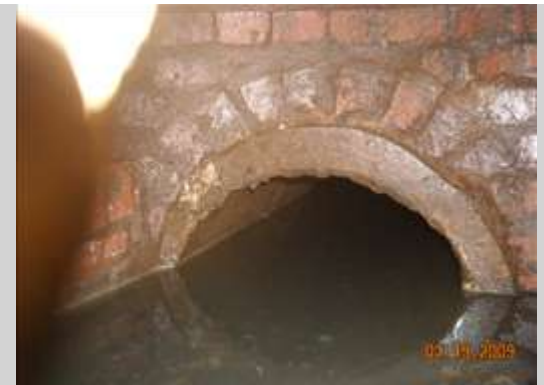
5 O'Clock Inflow

21 in. Circular Gravity Sewer  
Pipe In @ 5 O'Clock

Pipe Height: **21.6** (in.) Rod and Bar (Angled)  
Pipe Material: **Clay** ☐ Pipe Lined  
Invert Depth: **19.60** (ft.) Flow Characteristics: **Slow**  
Deposits: ☐ None ☒ **Mud** ☒ **Sludge** ☐ Debris ☐ Grease  
Silt Depth: **6** (in.) Deposits Extent: **Medium**  
Infiltration: **None** Pipe Seal Cond: **Sound**

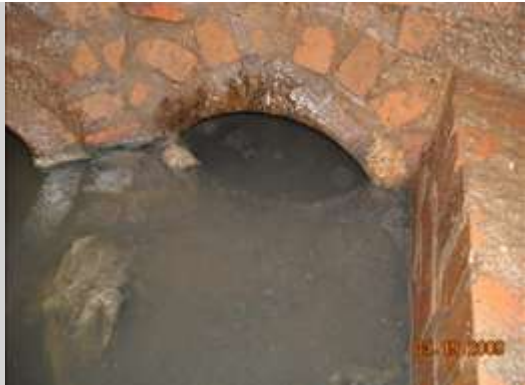
6 O'Clock Inflow

18 in. Circular Gravity Sewer  
Pipe In @ 6 O'Clock

Deposits: ☐ None ☒ **Mud** ☒ **Sludge** ☐ Debris ☐ Grease

Silt Depth: **4** (in.) Deposits Extent: **Medium**

Infiltration: **Weeper** Pipe Seal Cond: **Sound**
